Property Inspection Report

26 Riverview Terrace, Whakatāne, Whakatāne

Inspection date: 16/08/2023 10:11 PM

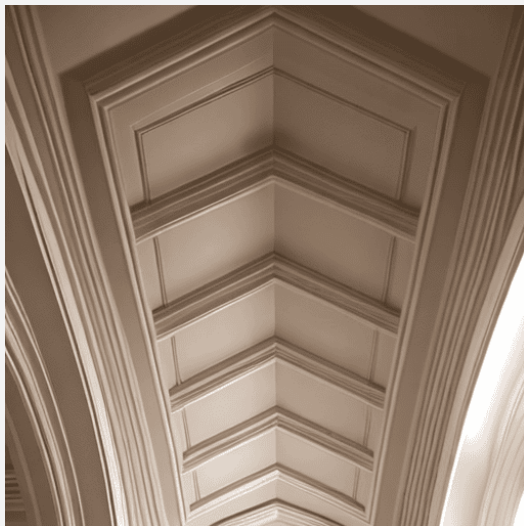
Hallway 1

hallway is clean

Feature	Condition
Floor Covering	Good
Ceiling	Good
Lights/Power Points/Switches	Good
Storage Cupboard	Good
Hot Water Cylinder	Good
Smoke Alarms	Good
Walls	Good
Stairs / Balustrade	Good

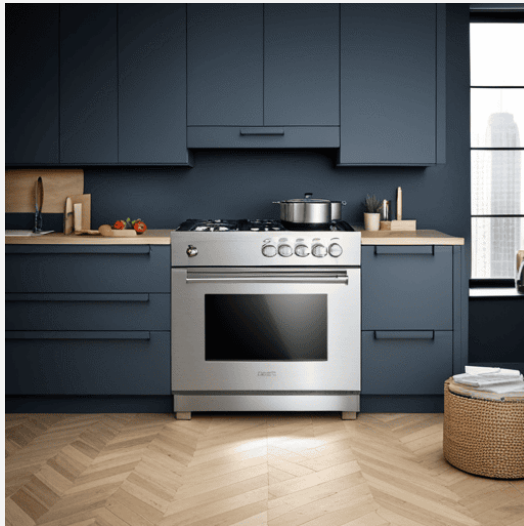
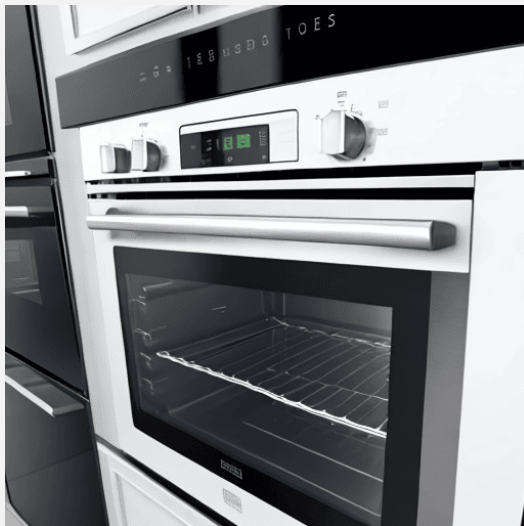
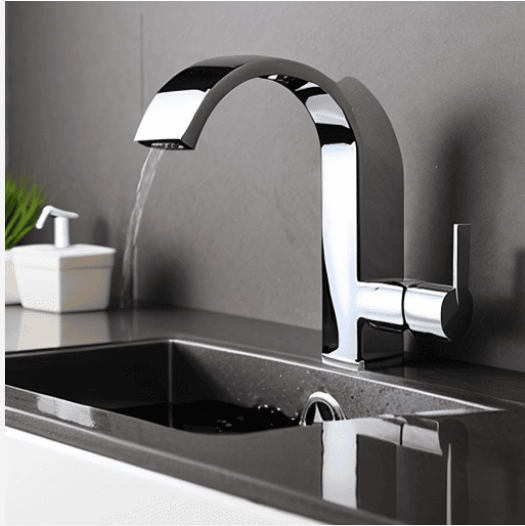
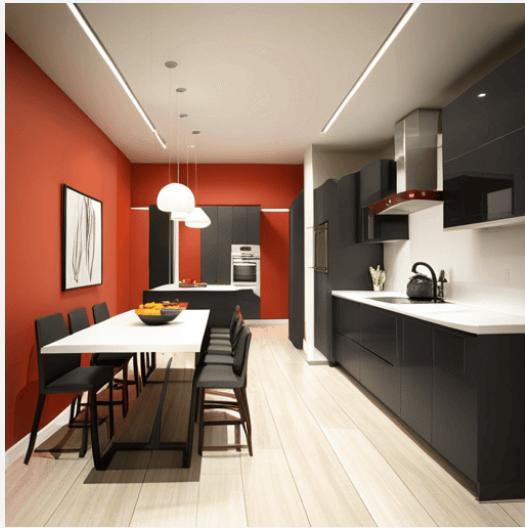
Kitchen / Dining 1

Small draft from the kitchen window.

Feature	Condition
Floor Covering	Good
Ceiling	Good
Lights/Power Points/Switches	Good
Walls	Good
Door	Good
Windows	Needs Attention
Curtains / Blinds	Good
Extractor Fan	Good
Sinks / Benches	Good
Cupboards	Good
Stove / Oven / Hob	Good
Extractor Fan	Good

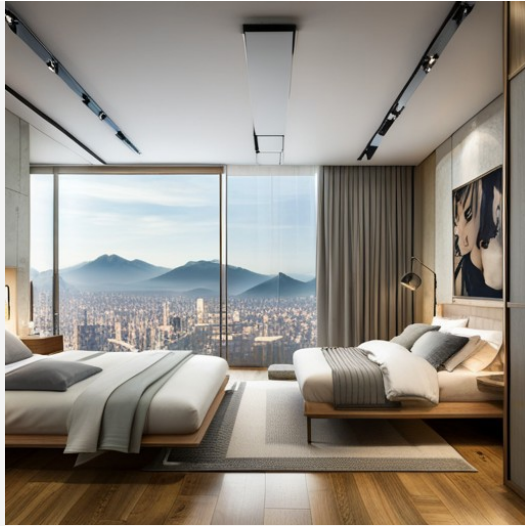
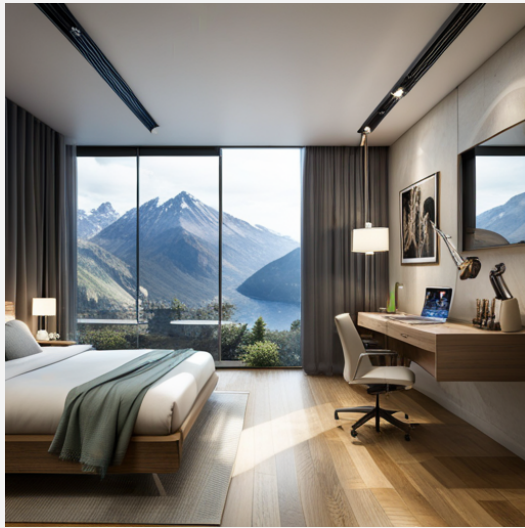
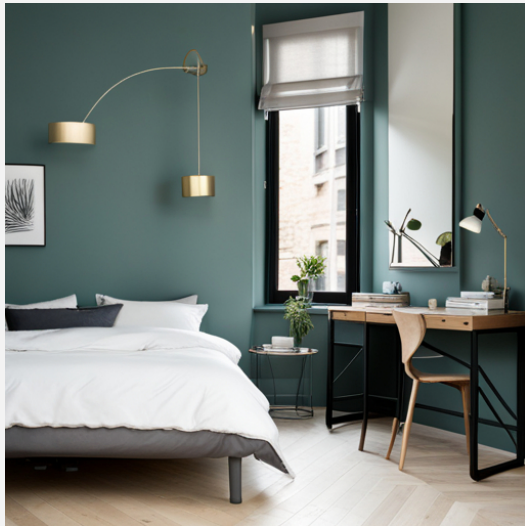
Bedroom 1

bedroom 1 all ok

Feature	Condition
Floor Covering	Good
Ceiling	Good
Lights/Power Points/Switches	Good
Walls	Good
Door	Good
Windows	Good
Curtains / Blinds	Good

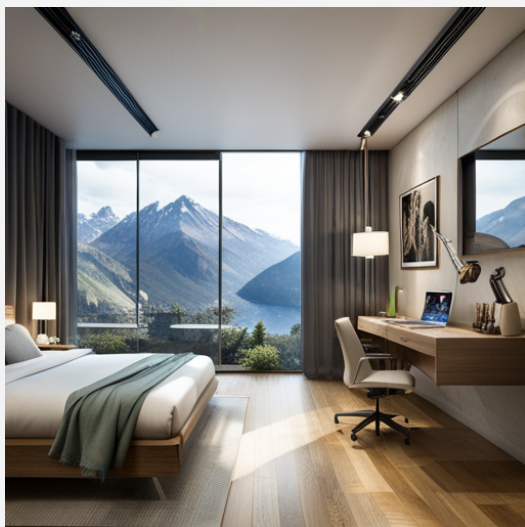
Bedroom 2 is all good.

Feature	Condition
Floor Covering	Good
Ceiling	Good
Lights/Power Points/Switches	Good
Walls	Good
Door	Good
Windows	Good
Curtains / Blinds	Good

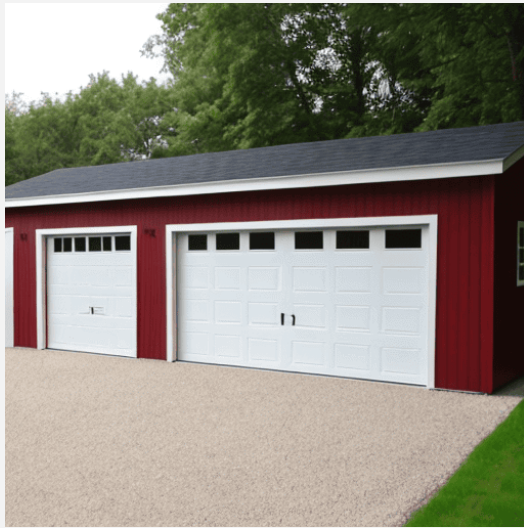
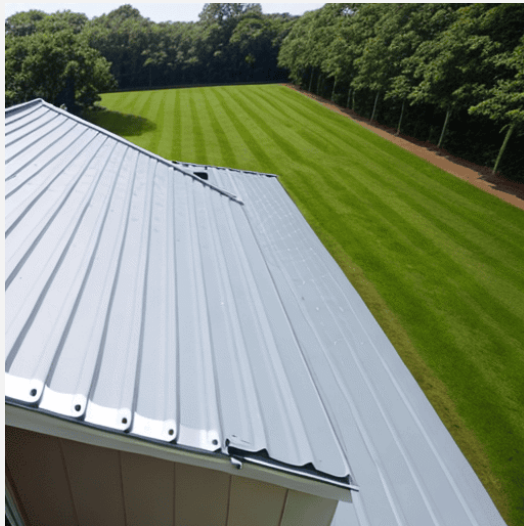
Garage / Carport 1

Garage roof is leading into the ceiling.

Feature	Condition
Garage Door	Good
Ceiling	Needs Attention
Lights/Power Points/Switches	Good
Walls	Good
Door	Good
Garage Floor	Good
